Manhole Inspection Summary

Manhole # S71K__007MH

Insp Date: **1/29/08 11:15 AM**

Location Address: **6720 Graceland Ave.**

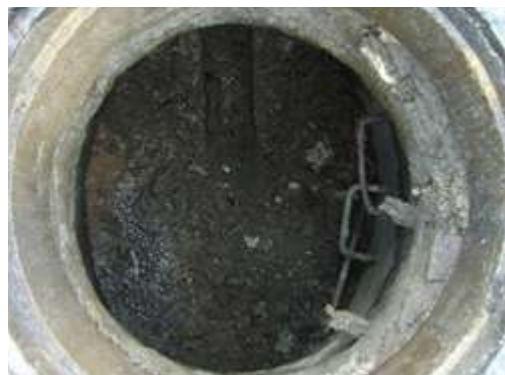
Top View

Comments **A LOT OF MUD AND DEBRIS IN THE CHANNEL.**

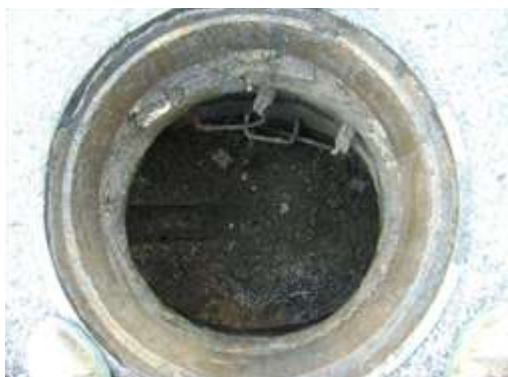
Defect 1

frame offset defect .50 in.

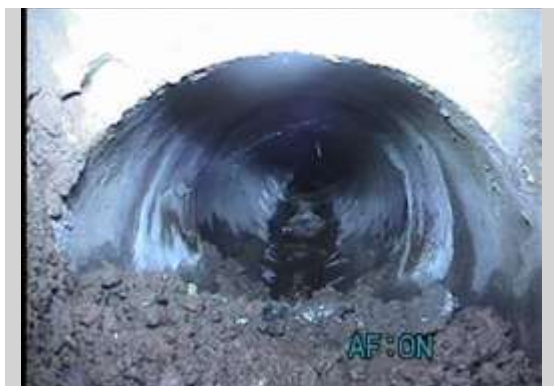
12 O'Clock Outflow

6 in. Circular Gravity Sewer
Pipe Out @ 12 O'Clock

Deposits: ☐ None ☐ Mud ☒ **Sludge** ☐ Debris ☐ Grease

Silt Depth: **0.25** (in.) Deposits Extent: **Light**
